LANDSLIDES AND RELATED FEATURES

OF THE EAST-BRADY, PA. QUADRANGLE

by
John S. Pomeroy
1979

OPEN FILE MAP 79-1314 (H-4)

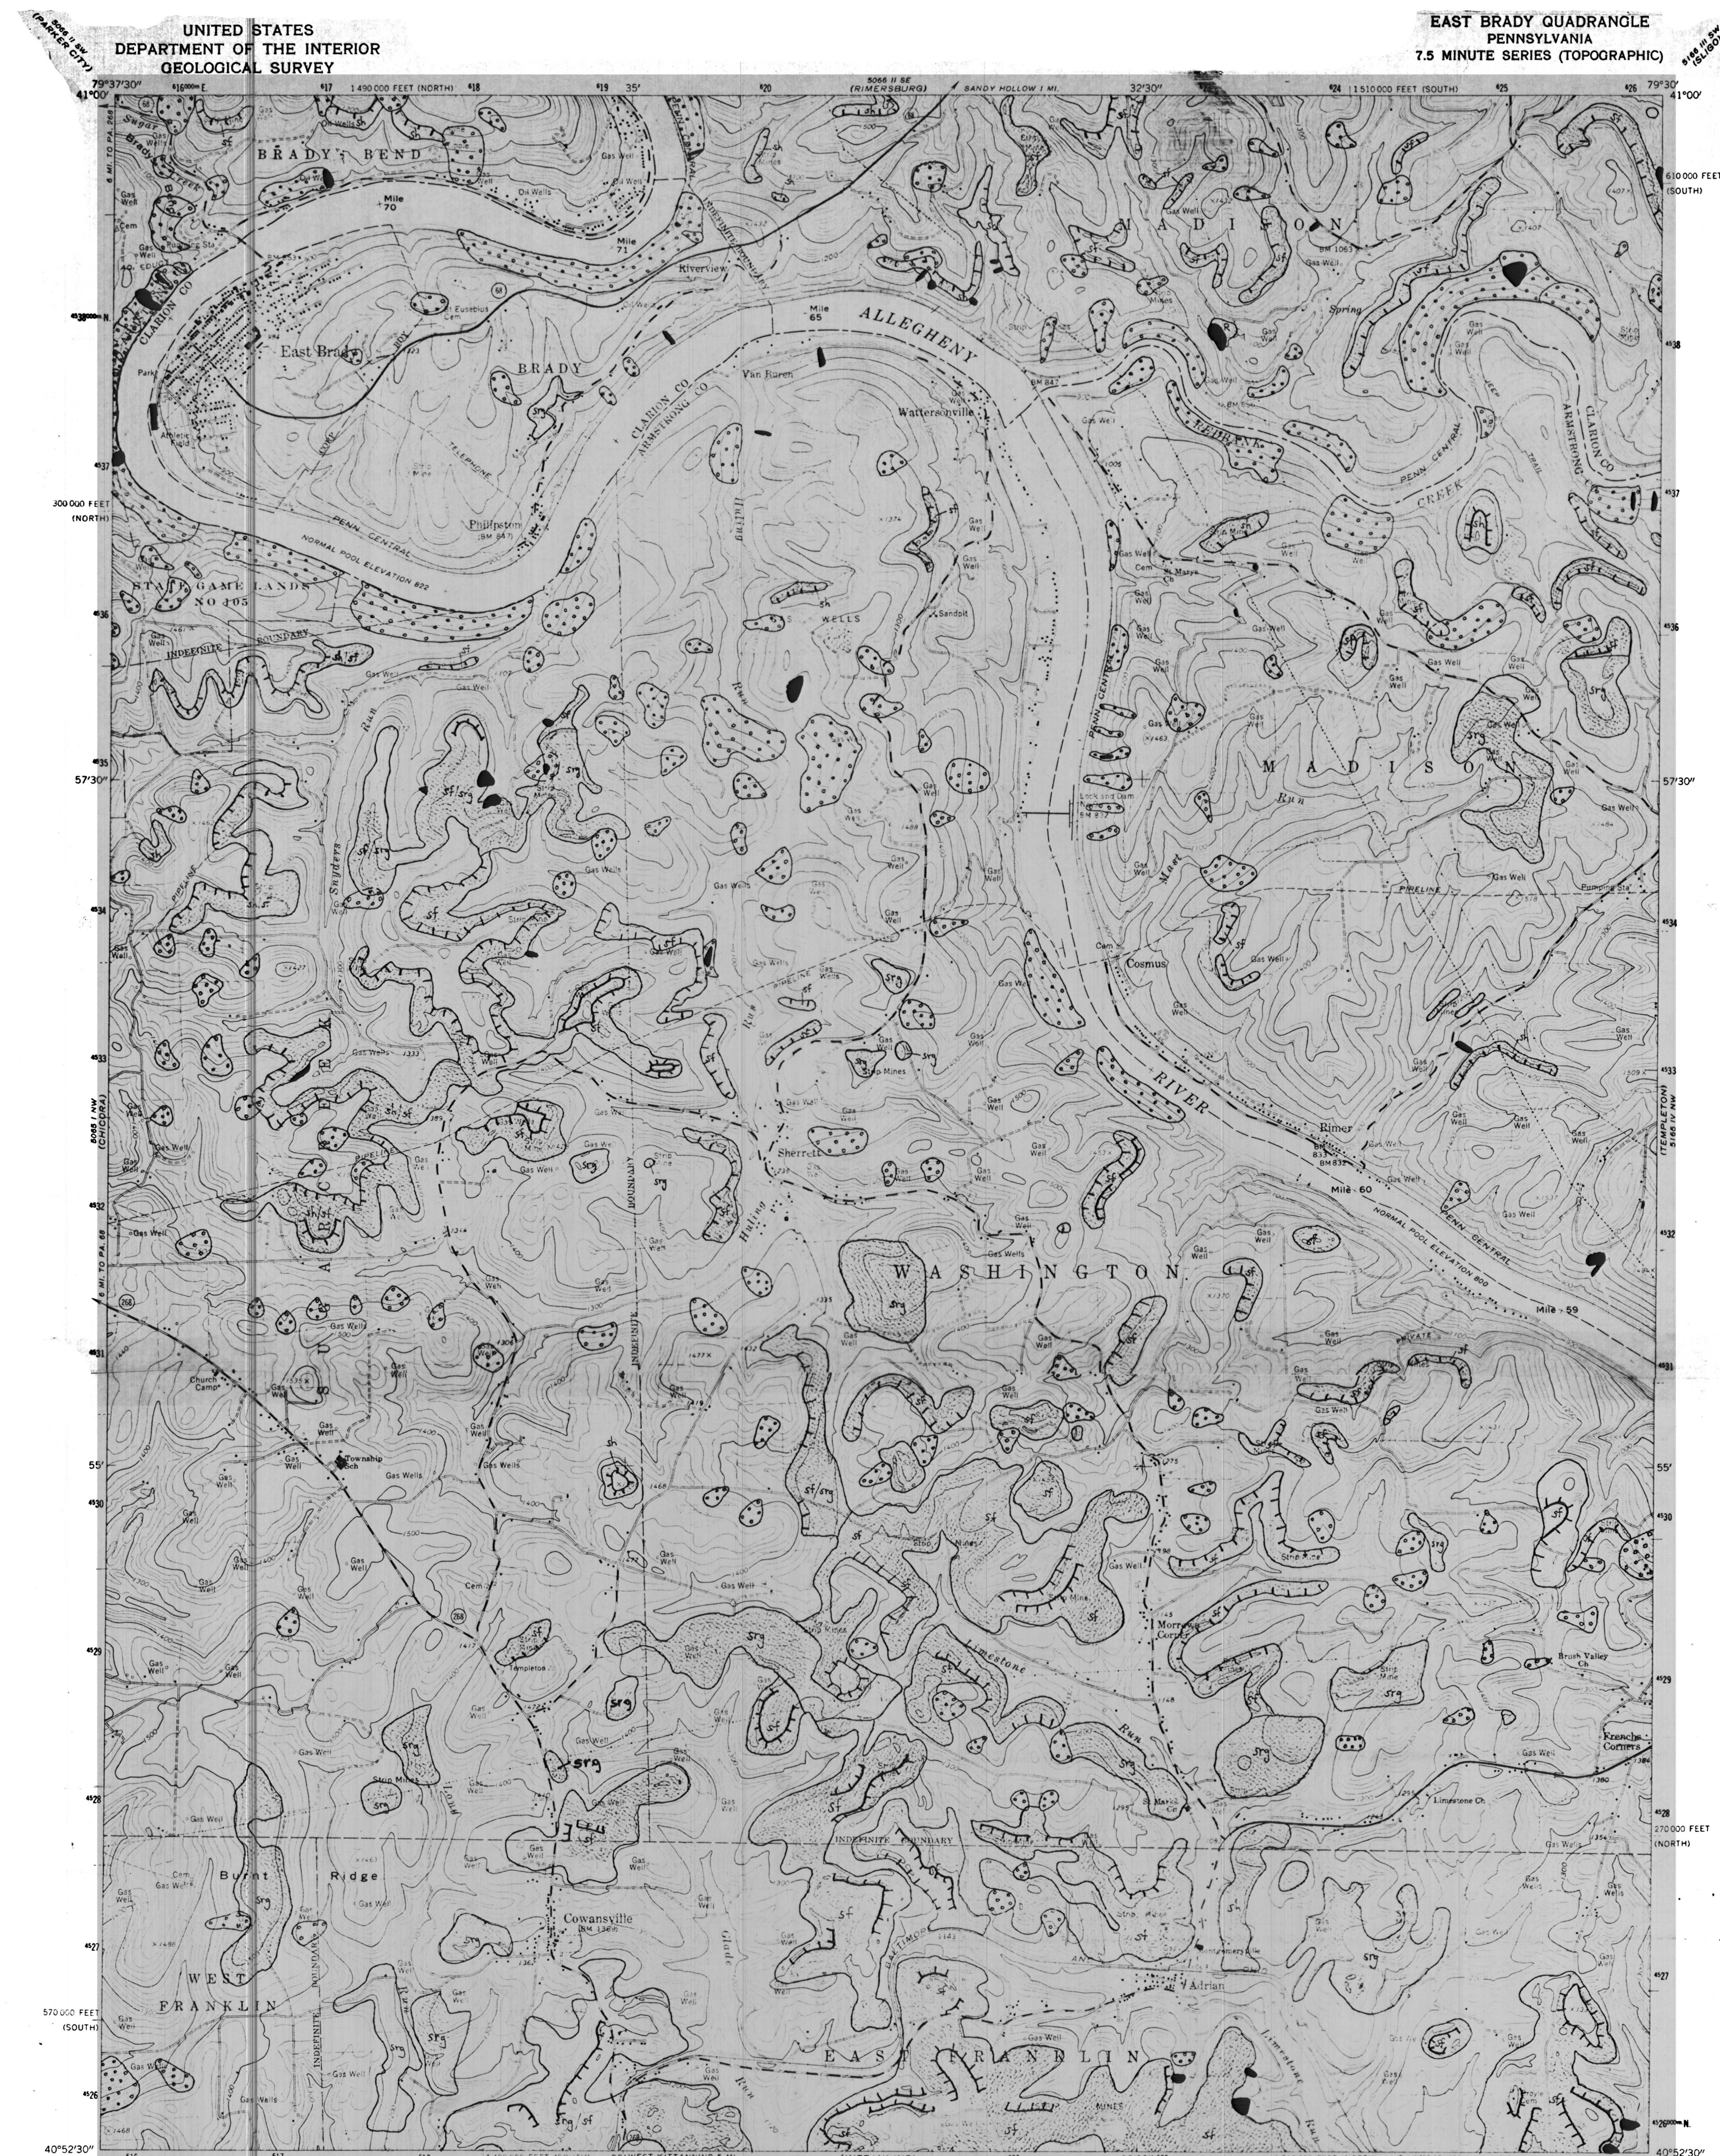
ACTIVE OR RECENTLY ACTIVE LANDSLIDE

Complex landslide composed of earthflow, debris
slide, earth and rock slump. Identified from
historical records, and from scars, debris and
other field evidence. Ground extremely unstable;
sliding accelerated by excavation, loading and
changes in drainage conditions. May include
areas with several active slides too small to
be shown separately. Questioned where doubtful.

OLD LANDSLIDE

Area of extensive hummocky ground caused by
earthflow and earth and rock slump. Lacks
clear evidence of active sliding. Relatively
stable in natural, undisturbed state,
generally not affected by small structures properly
sited in areas away from the edge of the toe;
can be reactivated by extensive, rapid exca-
vation, loading, and changes in ground water and
surface water conditions. Area of old landslide
probably includes recent ones not identified
from field evidence or otherwise documented.
Upslope boundary of landslide generally defined
by modified scarp, but downslope (toe) may be
gradational and not well defined. Questioned
where doubtful.

COLLUVIAL SLOPE

Valley wall along major streams with slope as
steep as 40° (85%); stony, clayey silt soil up
to 50 ft. (15 m) thick; commonly buttressed by
a terrace or bench at the toe of the slope; very
susceptible to sliding by cutting of toe area,
removal of terrace or bench, and overloading;
slide commonly activated without apparent cause.

AREAS SUSCEPTIBLE TO DEBRIS FLOWS AND DEBRIS
AVALANCHESPrimarily shallow, narrow ravines and chutes with
accumulation of stony colluvium generally 10 ft.
(3 m) or less in thickness; susceptible to rapid
movement during intense rainfall. Most ravines
and chutes designated show evidence of former
debris flows and avalanches. Symbol & designates
historical debris flow or debris avalanche.

AREAS SUSCEPTIBLE TO ROCKFALL

Steep, locally vertical, natural and man-made
slopes and cliffs, 15 ft. (4.5 m) or more high;
formed dominantly of sandstone, limestone, sandy
shale, mudstone and claystone. Interbedded mud-
stone, claystone and shale weather rapidly leaving
sandstone and limestone rock faces unsupported.

Information shown is intended as a
general guide to ground conditions as of
the date of field check. Additional
landslides and rockfalls should be anticipated
in all map units. The map unit depicts
the dominant condition in the area delineated
and variations in slope stability may occur
at any point in the unit. This map is suit-
able for general planning purposes and as a
supplement to more detailed studies for site
selection. The map cannot be used as a sub-
stitute for detailed geologic and engineering
investigations to establish design and
construction criteria of specific sites.
Some symbols may not appear on this map
because the description is applicable to a
series of maps.
